# Tool Health Check Application Eliminates Scrap from Runout Caused by Chip Interference

RESULTS - INSTALL 9618

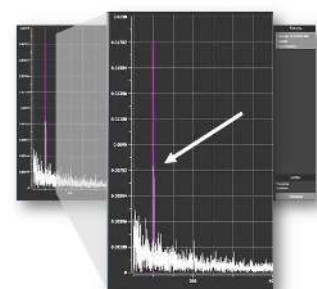
Acceptable signal level (tool loaded properly)

Signal level exceeded (tool loaded improperly)

When a chip significant enough to create the runout penetrates the tool clamping area there is a resultant increase in the (vibration) signal amplitude measured with DTect-IT, which will generate an alarm. The part program checks for the DTect-IT alarm and stops the process before a bad part is produced.
